The following pictures show the work that the NH DOT Bridge Division did on the Old Mill Bridge. The concrete abutments/footings had settled and were cracked. It was a case where the metal pipe was holding the abutments in place instead of the abutments supporting the metal pipe. DOT fabricated and installed rebar and welded it to the metal pipe. They then poured a new floor and partial side walls. Upon completing this DOT fabricated rebar frames and poured new wingwalls and a headwall on the upper end of the bridge. DOT did an excellent job and it only cost the Town 20% of the total cost of the repair.

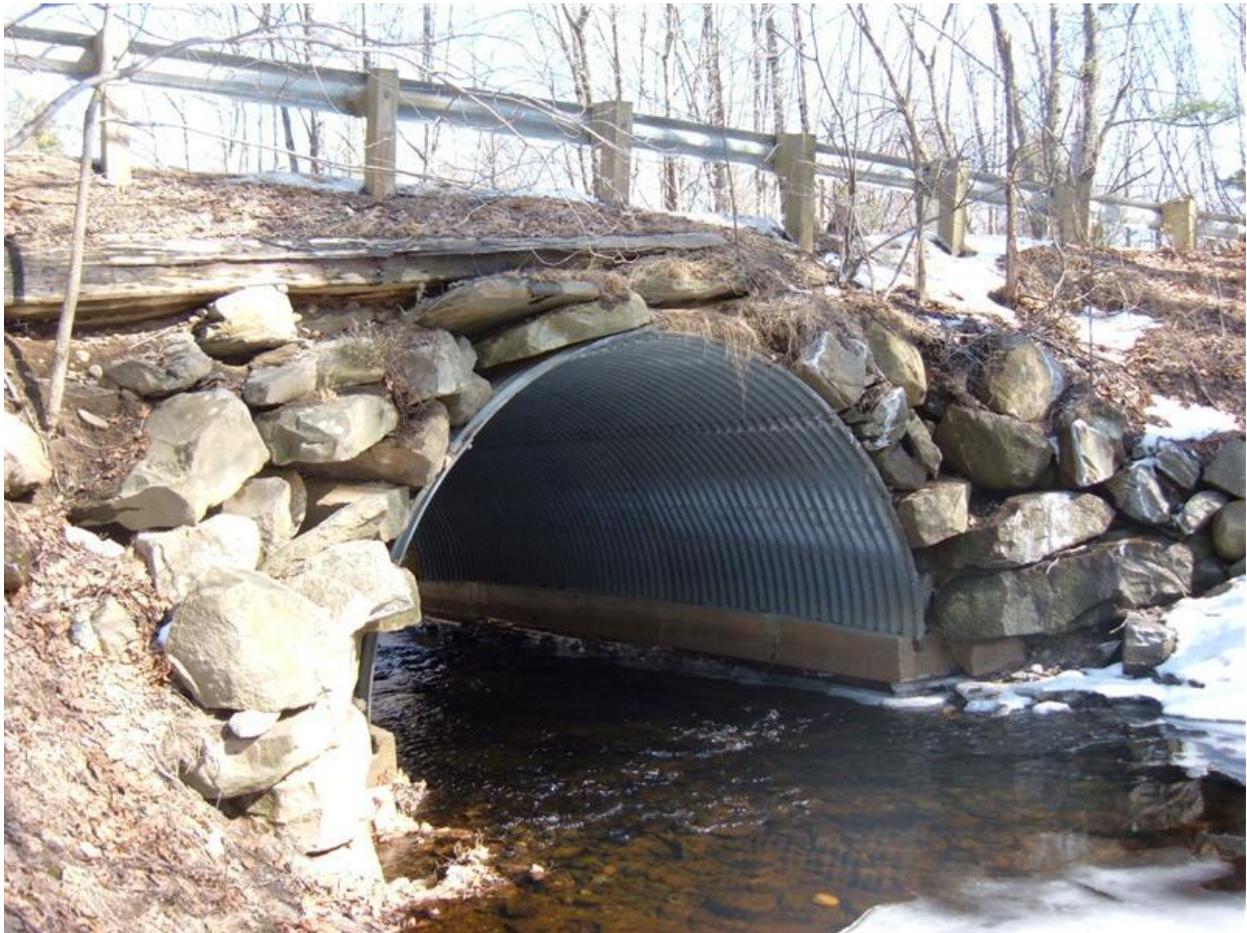
Old Mill Bridge before repair

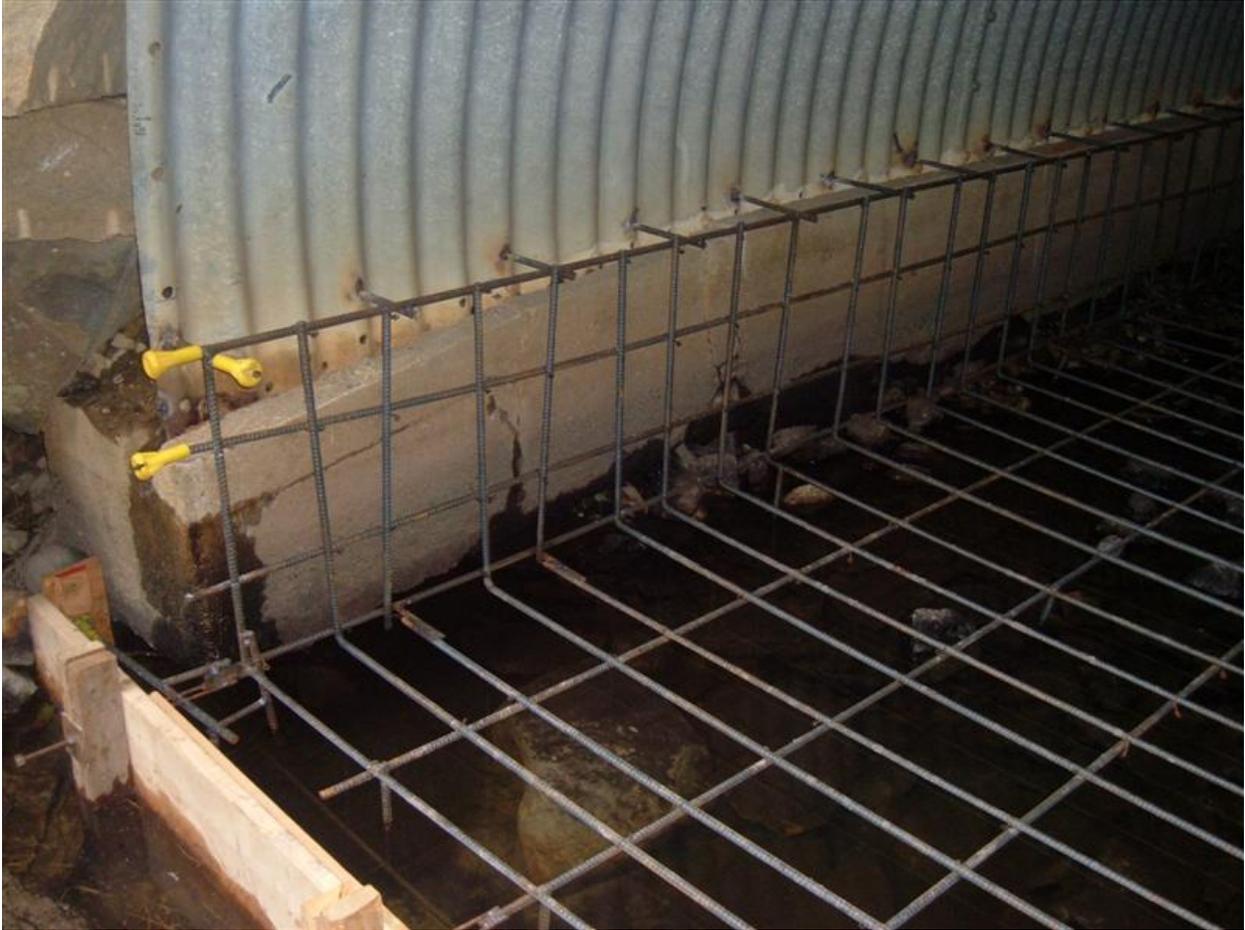
Rebar placement. Notice undermining of concrete abutments

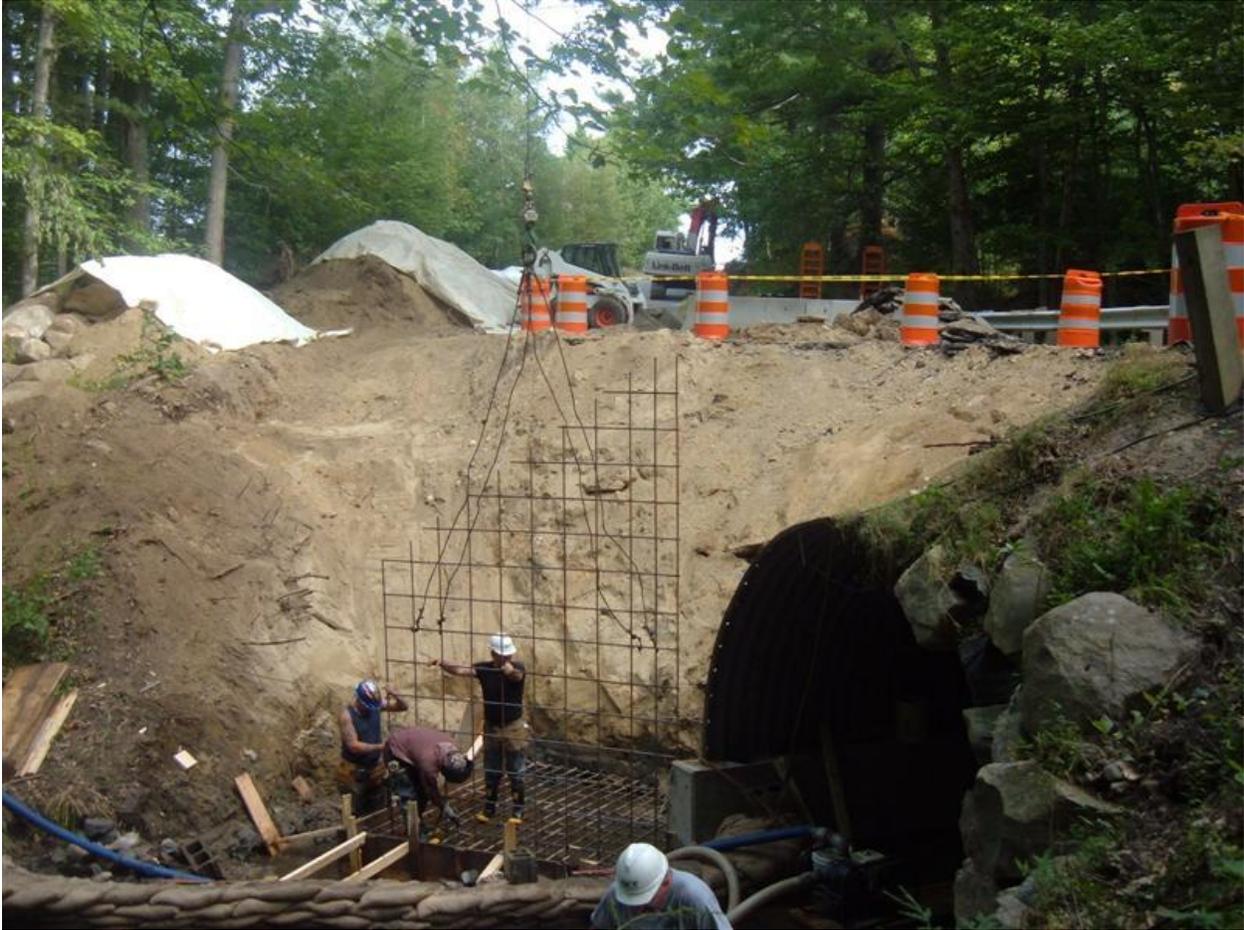
Placing rebar for wing walls

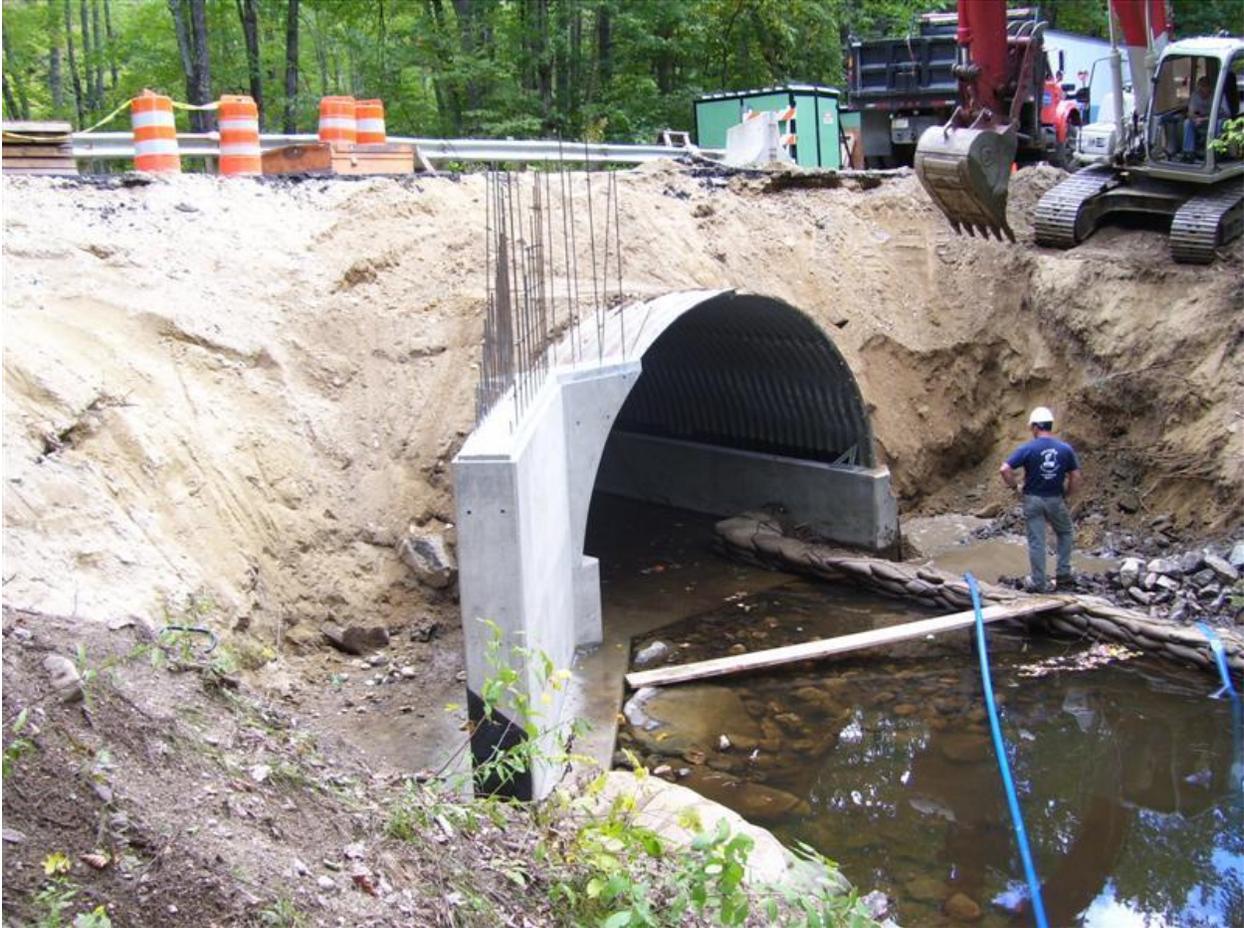
North wing wall done-Excavating for south wing wall.

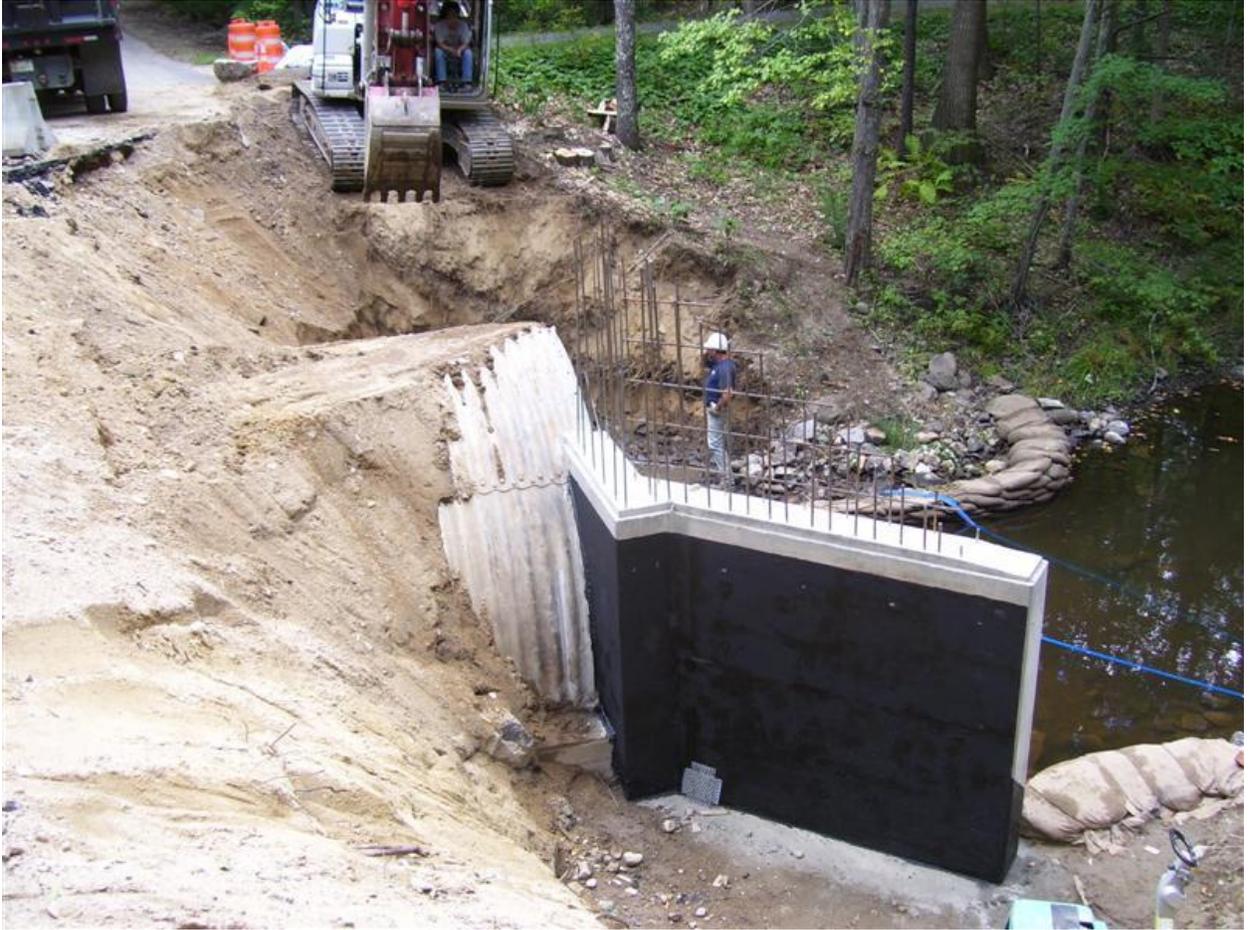
Backside of North wing wall

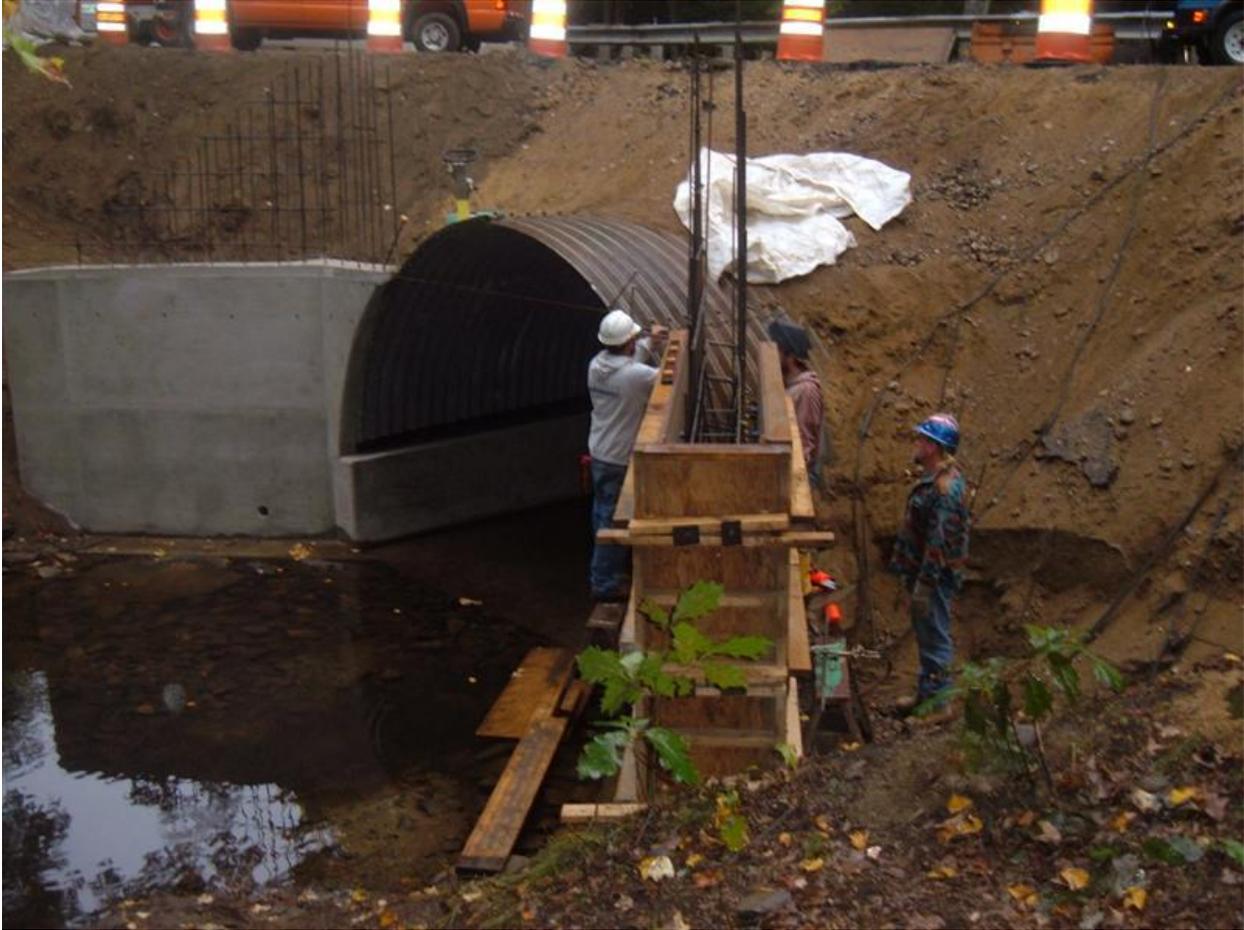
Installing forms for south wing wall

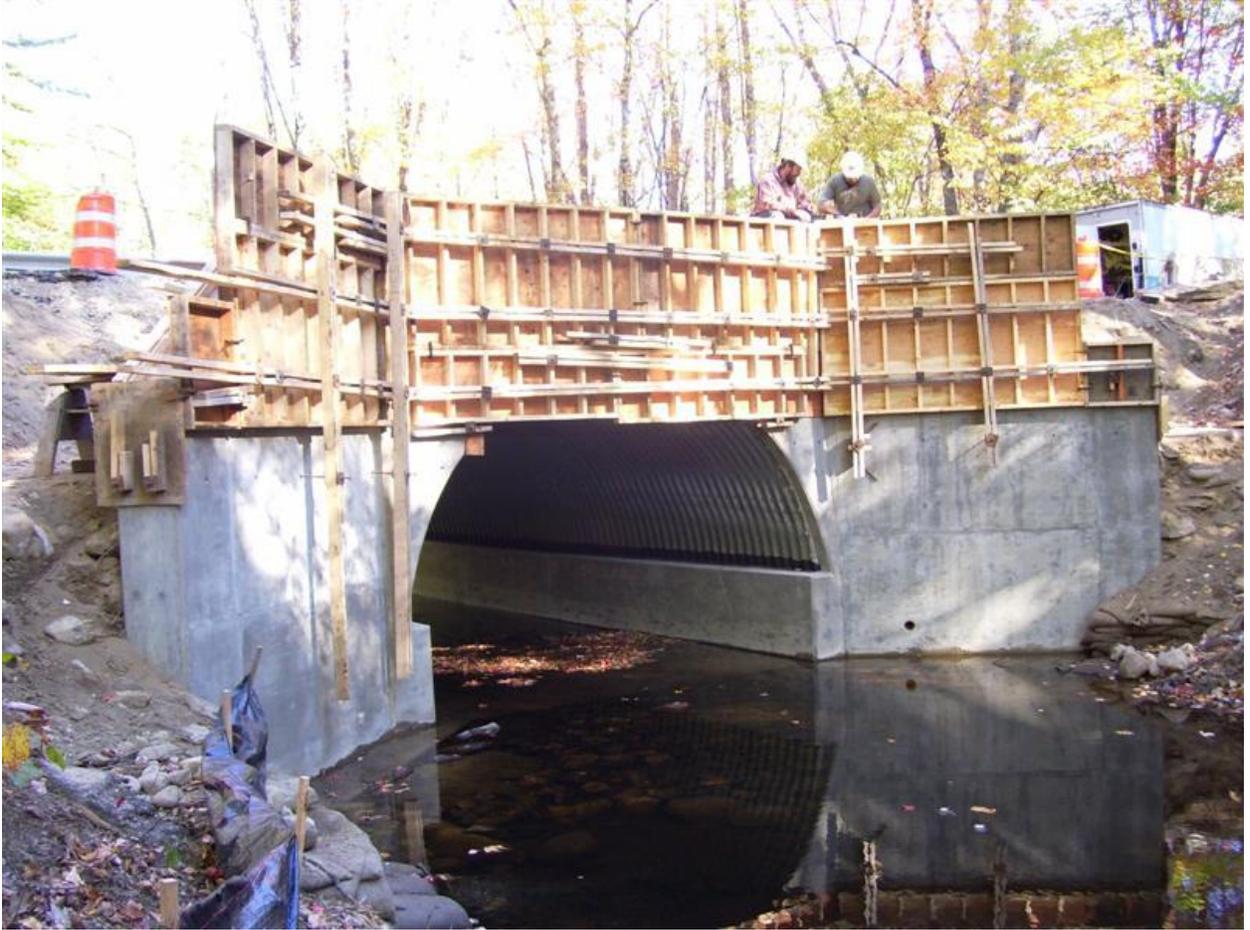
Installing forms for concrete header

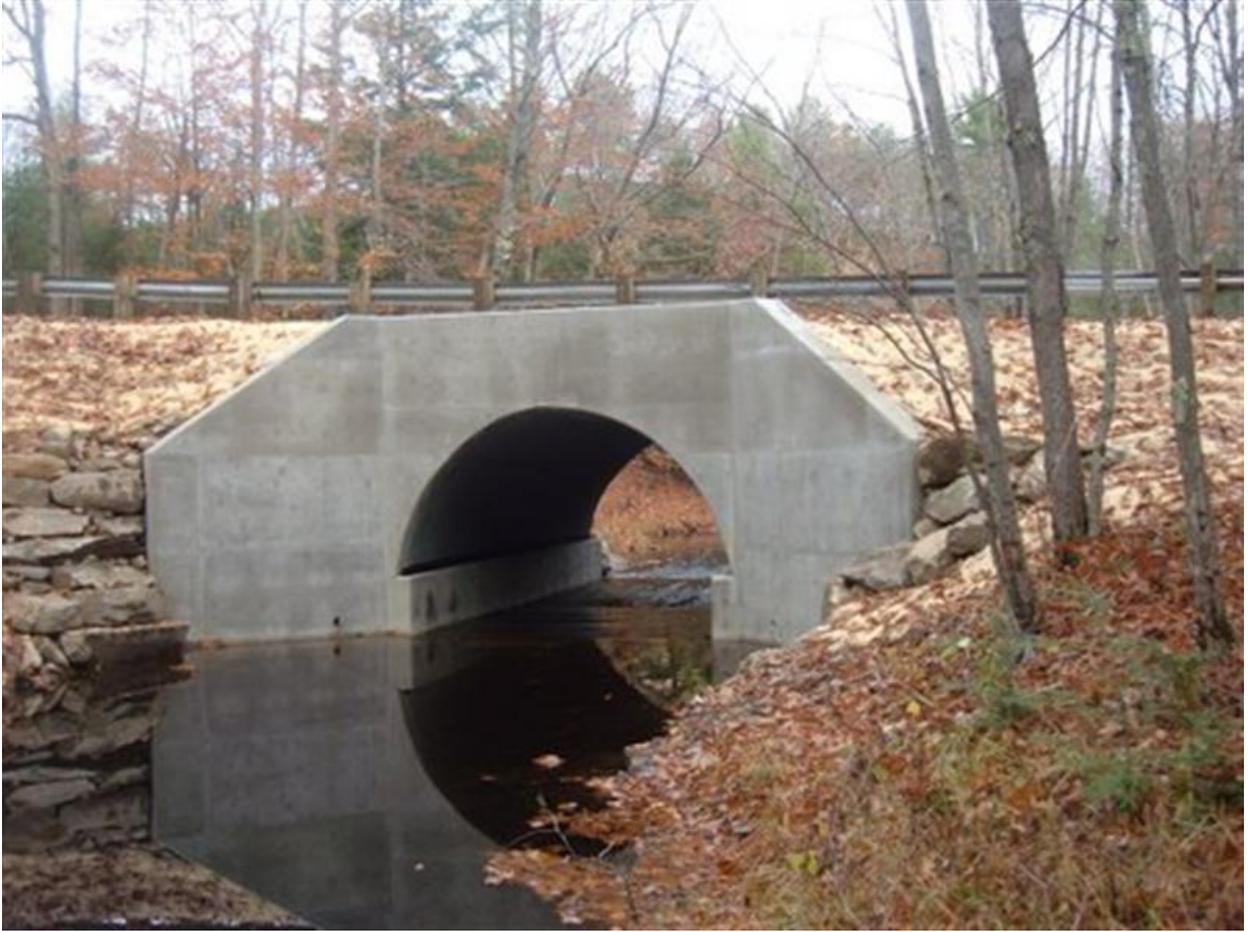
Finished product.
