The New Hampshire Municipal Energy Assistance Program

Decision Grade Audit Report

Lee Public Library
7 Mast Road Lee, NH 03861

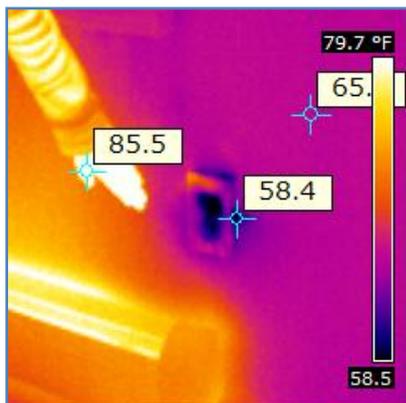
Radiant heat loss describes how heat waves, or infrared radiation, pass through space from one surface to another within its view. For example, the heat from a hot copper pipe will radiate towards cooler surfaces around it, like an exterior wall. The heat can then conduct through building materials to the exterior.

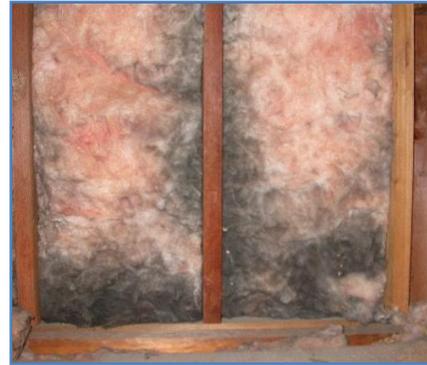
Just as BTU's conduct through solid materials, water vapor diffuses through solid materials. Some materials are more resistant to vapor diffusion, such as polyethylene, and so we use these to try and form a vapor barrier on the inside of the thermal boundary in an attempt to slow the amount of vapor diffusion. Small amounts of vapor traveling through a properly constructed building envelope will diffuse all the way to the exterior, and not cause any damage. **If a large amount of vapor is allowed to enter a wall cavity, the molecules will condense on the nearest cold surface.** When this happens, moisture can build up on the inside of the exterior wall sheathing, or on other surfaces. This will cause a number of problems including long term damage to insulation and structural components, as well as the promotion of mold growth.

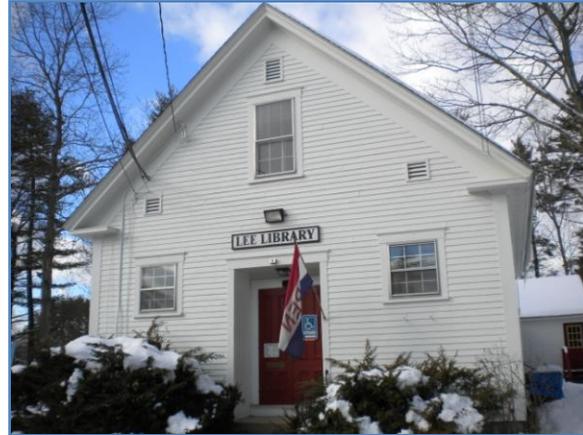
There are three sections of this building. According to the Lee Portfolio Manager account the original section of this building was built in 1940. There have been two additions built on the rear side. This building is one story, with the rear addition basement serving as a children’s room. See below for building measurements. We have broken this building into three sections for this report with Section 1 being the front of the building.

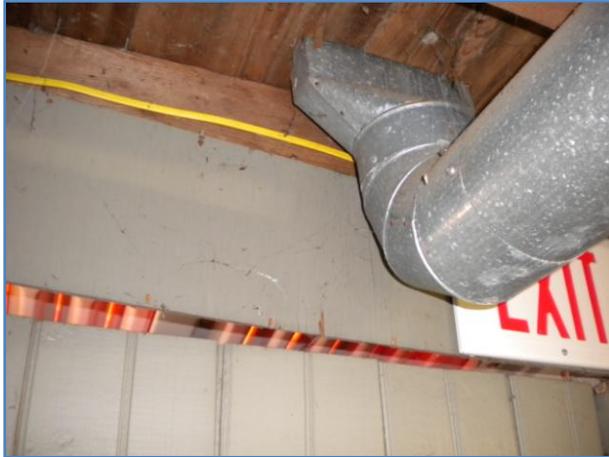
There is a large amount of air infiltration into this space. Figure 3 shows a large gap above the bulkhead door which allows cold air into the basement. The cobwebs visible in Figure 4 move wildly due to the amount of air coming in from around this basement window. This cold air is not only serving to cool down the ductwork located in this basement, but is also greatly contributing to the stack effect.

- Replace the bulkhead door with an insulated unit. Make sure that the new door provides insulative value as well as a good air seal.
- Make rigid foam inserts for the basement windows in Section 1. Install the inserts during each heating season, and remove during the warmer months. It is necessary to keep humidity levels as low as possible in basements and crawl spaces during the summer months.

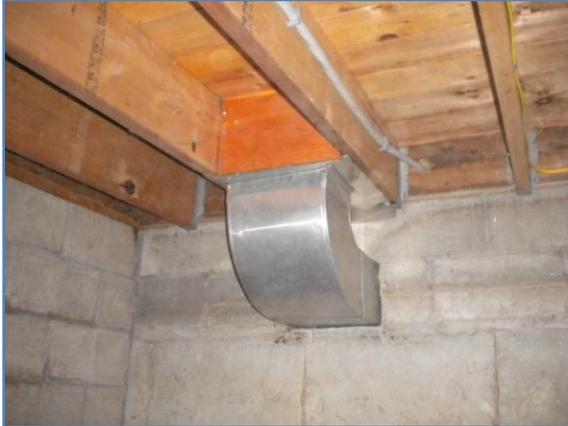
Figure 5

The middle section (Section 2) of the building sits over a crawl space. There are un-insulated concrete walls and a dirt floor at varying depths. Approximately half of the space has fiberglass insulation between the floor joists. There is no vapor barrier present. See Figures 5 and 6.

- Insulate the underside of the Section 2 floor. This should be done with closed cell spray foam, making sure that the foam comes down over the band joist and slightly overlaps the foundation wall.

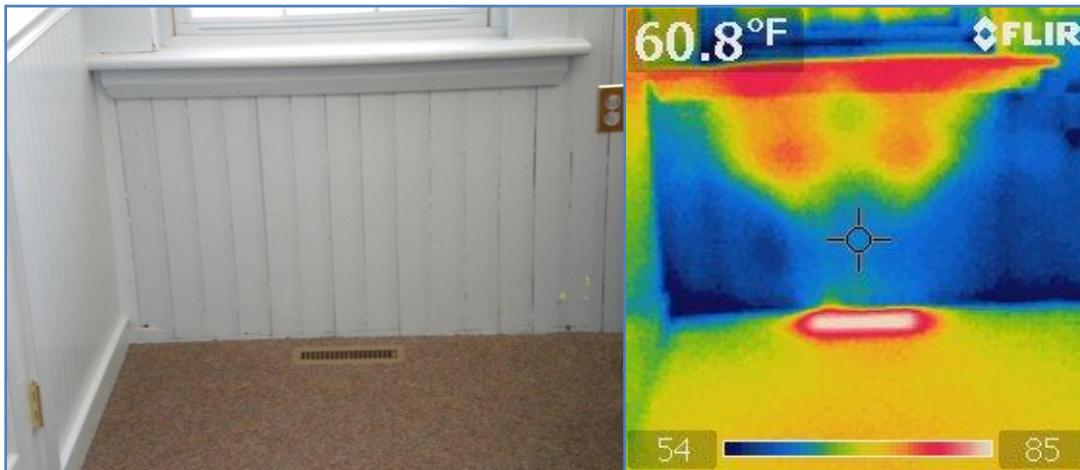
Figure 11

The exterior walls of Section 1 were constructed with 2x4” studs. The IR images in Figures 11 and 12 suggest that these walls have no insulation. We were able to look into a few different wall cavities to confirm this.

Figure 12 illustrates just how quickly heat from this supply air register is lost through the uninsulated wall.

- Have all the exterior walls of Section 1 filled with cellulose insulation. This would also be a good time to temporarily remove the window trim to seal and insulate around window frames, studs, sills, and headers.
- If at any point the building will undergo a major renovation, consult with a building performance analyst who specializes in super-insulated structures. A super-insulated building can require 75% less heating fuel than standard construction.

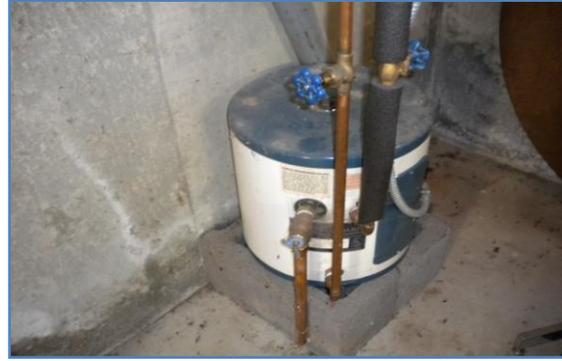
Figure 15

There is not a lot of domestic hot water (DHW) use in this building. There is only one lavatory and the hot water is supplied by the small electric hot water heater seen in Figure 16.

Though there are more efficient ways of producing hot water, this is not a very high priority. This tank, and the pipes, should certainly be wrapped with more insulation.
