# Town Offices Space Needs Assessment

Town Of Lee, New Hampshire 03824

October 2007

## **TOWN OF LEE, NH – TOWN CENTER STUDY OF EXISTING ELECTRICAL SYSTEMS**

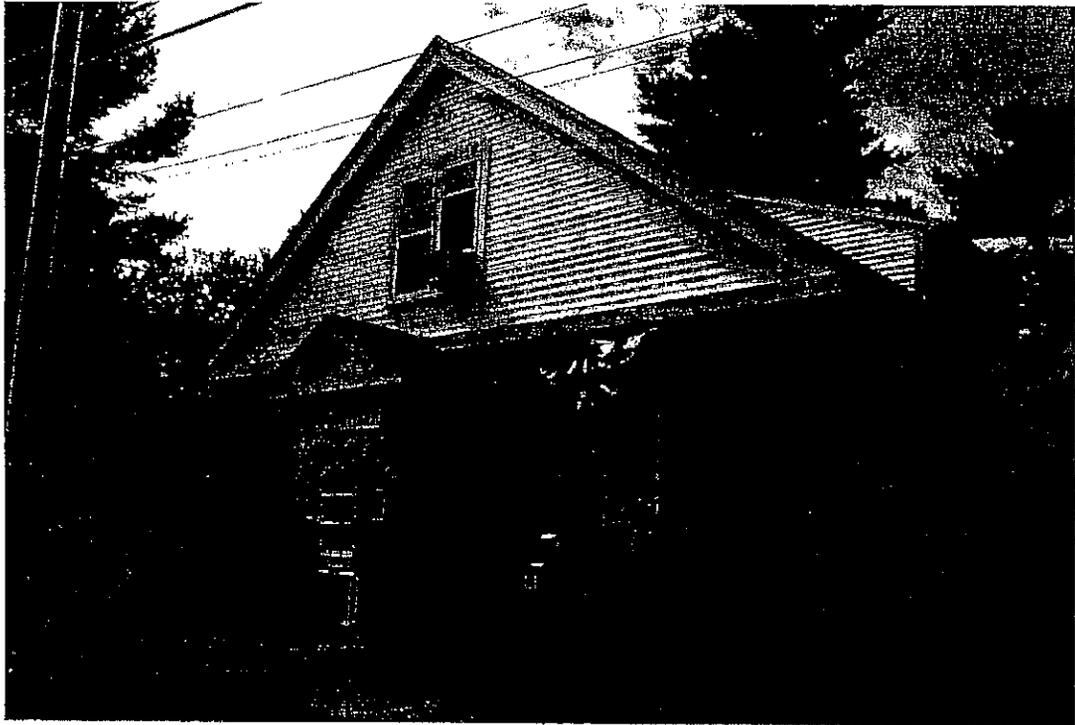
The Town Hall is housed in a former brick schoolhouse and a newer, wood frame addition at the rear. The main first floor room houses the Town Administrator, Town Bookkeeper, Town Secretary, files, a public access area and a meeting space. The wood clapboard rear addition includes two (2) toilet rooms, a small kitchenette, and the Town Clerk's office.

Accessed through an interior open stair, the 2nd floor area includes an office and open workroom for the Town Planner and his secretary. Above the newer addition is a mechanical room and storage room. An exterior stair at the rear provides a 2nd means of egress.

Deficiencies in the Town Hall include noncompliance with ADA (handicap accessibility to the 2<sup>nd</sup> floor, & ADA bathrooms); inadequate stair widths and hand railings, stair riser and tread dimensions; and other building and life safety code violations. There is a lack of sufficient, secure filing space, and public areas and staff workspaces are small and cramped.

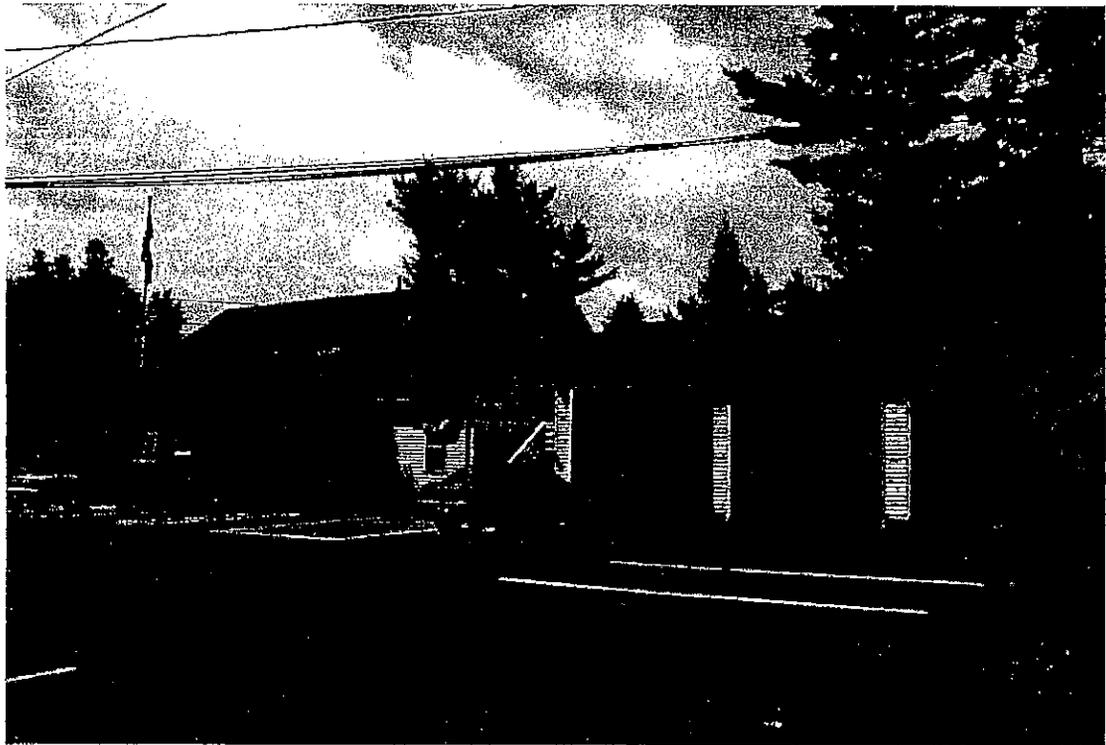
Town Hall & Storage Garage

The Town Hall and Town Hall Annex buildings share a common parking lot with the Town Library, the Historical Society building and a storage garage situated behind the Town Hall. (See attached site plan)

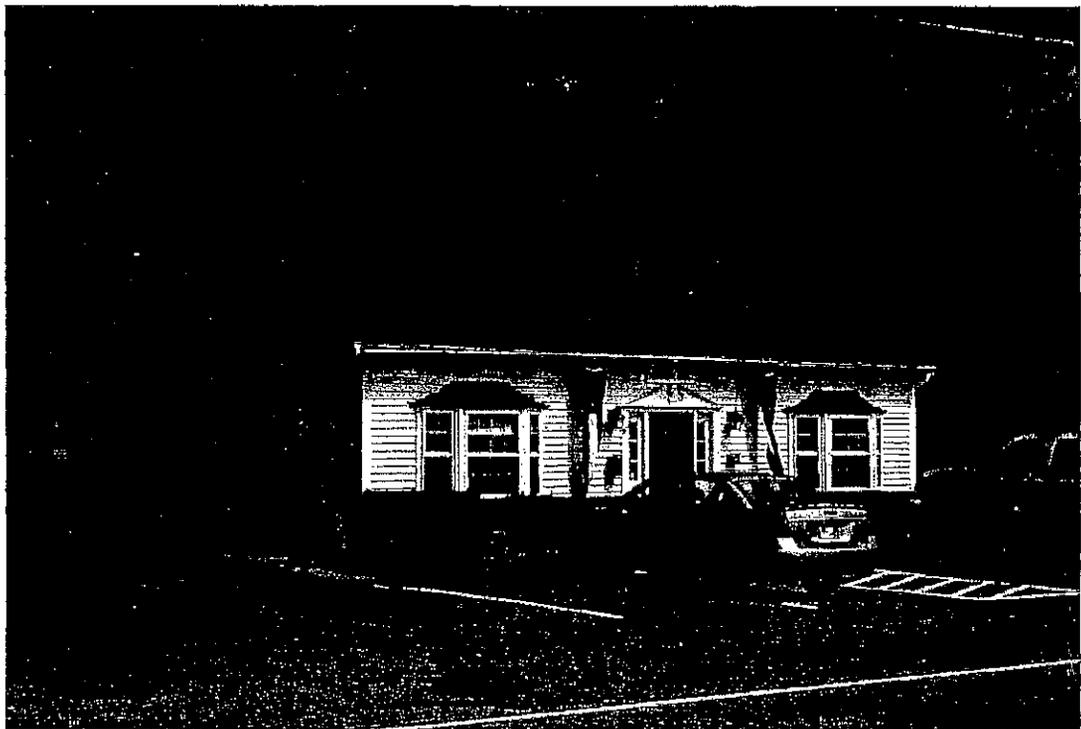
The Town Hall Annex building is used for offices, janitorial storage and maintenance workspace. It houses the Town Hall fire alarm and telephone systems, and includes a toilet room, Town Conservation Committee room, General Assistance Director office, two meeting rooms shared by the Recreation, Agricultural, and

<i>Use</i>	<i>Room Assignment</i>	<i>Square Feet</i>	<i>Comment</i>
Entry	Front Vestibule	48 sf	Second airlock door missing
Office	Meeting Room	200 sf	Central room
Office	Conference	187 sf	Exterior door without airlock
Office	Conservation Office	134 sf	Sufficient space
Office	Welfare Office	126 sf	Lacking security
Maintenance	Janitor/ Phone/ Fire	133 sf	Inadequate storage, no security

Toilet	Toilet	31 sf	Not ADA accessible
HVAC	Furnace	25 sf	Access through Toilet
Storage	Storage Vault	93 sf	Inadequate storage
Net SF		977 sf

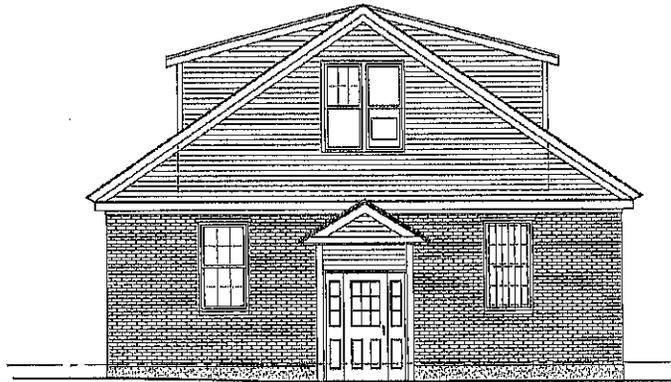
TOWN HALL STREET ELEVATION

- Built in 1846, at original Mast Road/Town Center location
- Greek Revival style of architecture, stone foundation, brick exterior, clapboard gable roof
- Underpinnings and granite doorstep came from the town's first meeting house, built about 1766
- Tramp House (Garage) constructed in 1920s with remodel/addition sometime in the 1950s
- Two story, clapboard addition constructed in 1968
- Library established in 1892 and located in second floor of town hall until 1962
- Currently serves as work space for town administrator, secretary, bookkeeper, welfare officer, tax assessor, IT administrator, town clerk/tax collector and assistant and the Code Enforcement officer and secretary

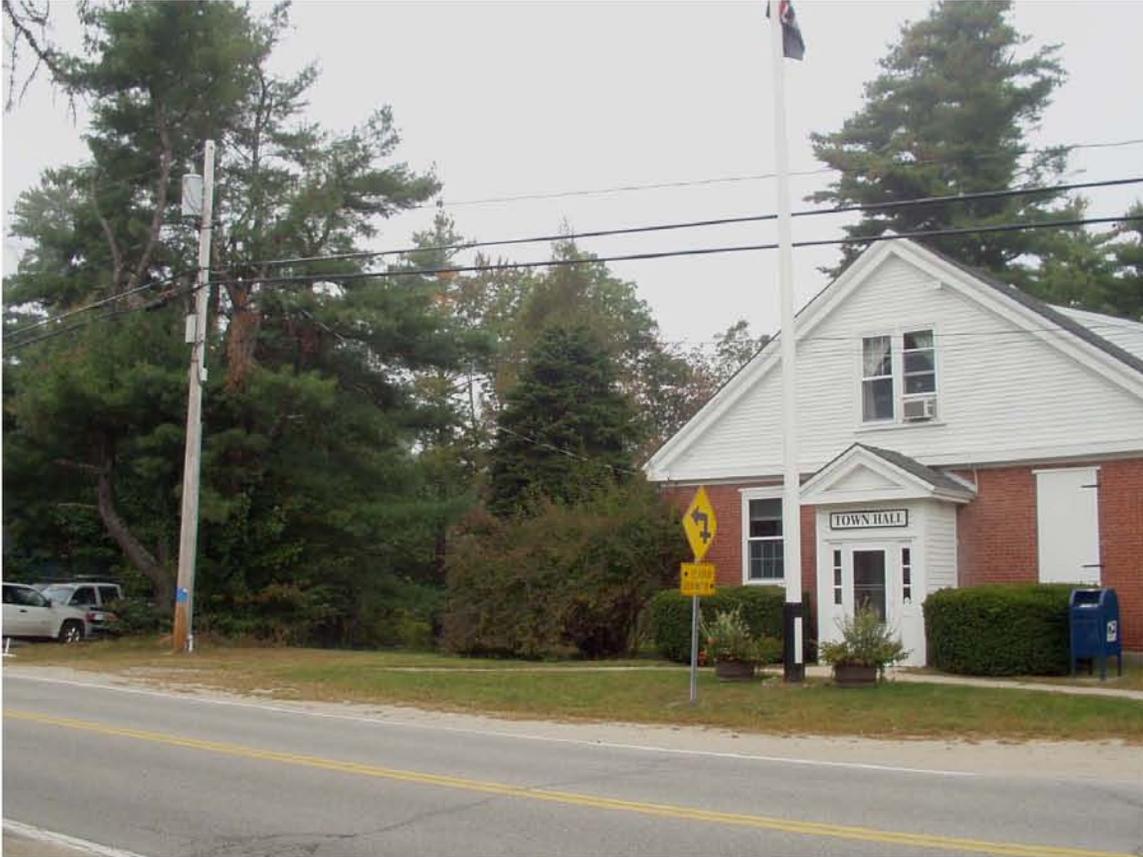
OVERHEAD SERVICE TO TOWN HALL – LAST PRIMARY LINE AND TRANSFORMER

There is single phase electrical power at 120/240 volts to each building. Electrical utility primary power comes from the south overhead on utility poles. The high voltage primary power stops at the pole to the south of the Town Hall with a pole mounted transformer that provides secondary, 120/240v single phase power to all five buildings. This is done with overhead secondary power and service laterals run to each building, with the exception of the Historical Society Building which is fed underground from the Library panel. The telephone and CATV cables come overhead from the south with the secondary power. Comcast is the TV cable provider. The nearest three phase primary utility power is five poles away to the north, about 1500 feet.

- The Town Hall building has a 100 amp, 120/240 volt, single phase service coming in overhead from a pole to the south at the street.
- The main panel is an old Federal Pacific (FPE) 125 amp panel with a 100 amp main breaker and 24 single pole full size positions all full with one 30/2 (30 amp, 2 pole) breaker for the kitchen range; 60/2 breaker feeding an upstairs sub panel; a 20/2

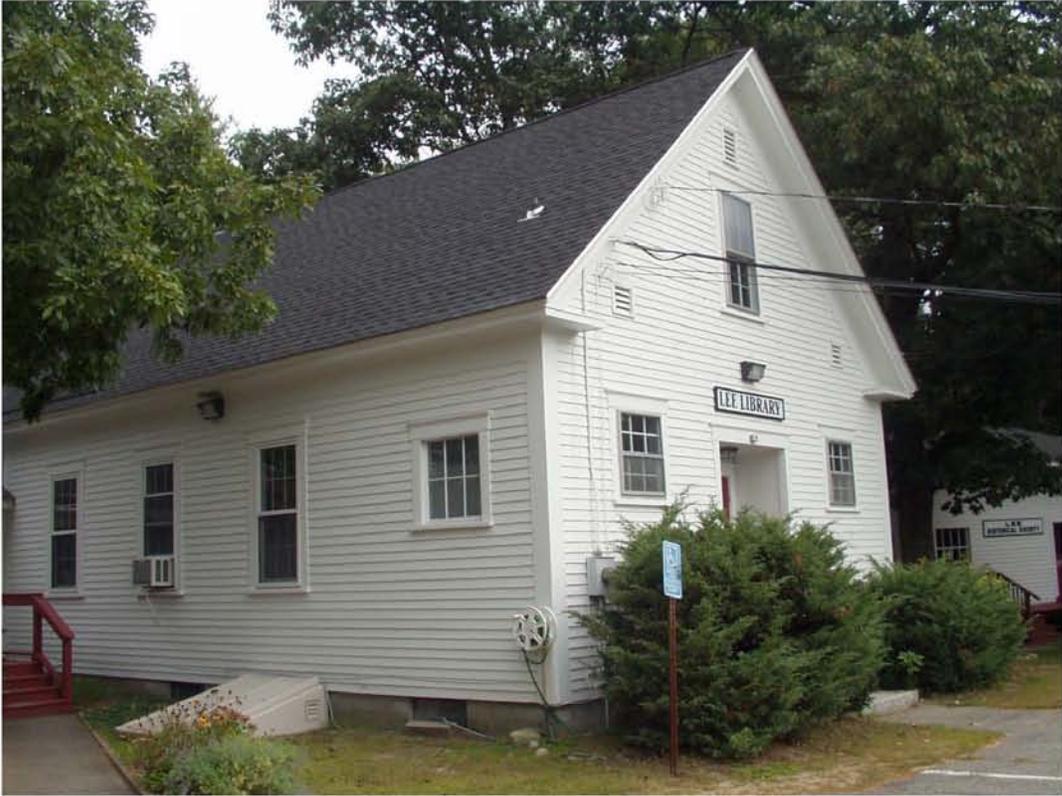
**LIBRARY SERVICE ENTRANCE AND METER**

- The Library has a 200 amp, 120/240 volt, single phase service coming in overhead to a meter on the front of the building and a relatively new main electrical panel in the basement.
- The main panel is a Siemens ITE G4040MB 1200 CU panel with a 200 amp main breaker and 42 breaker positions.
- There are the following breakers: 70/2 breaker which feeds the Historical Society Building; 30/2 breaker for the range; 100/2 feeding a sub panel in the new addition (basement); 50/2 breaker for the central air conditioning; and the rest are 20 amp and

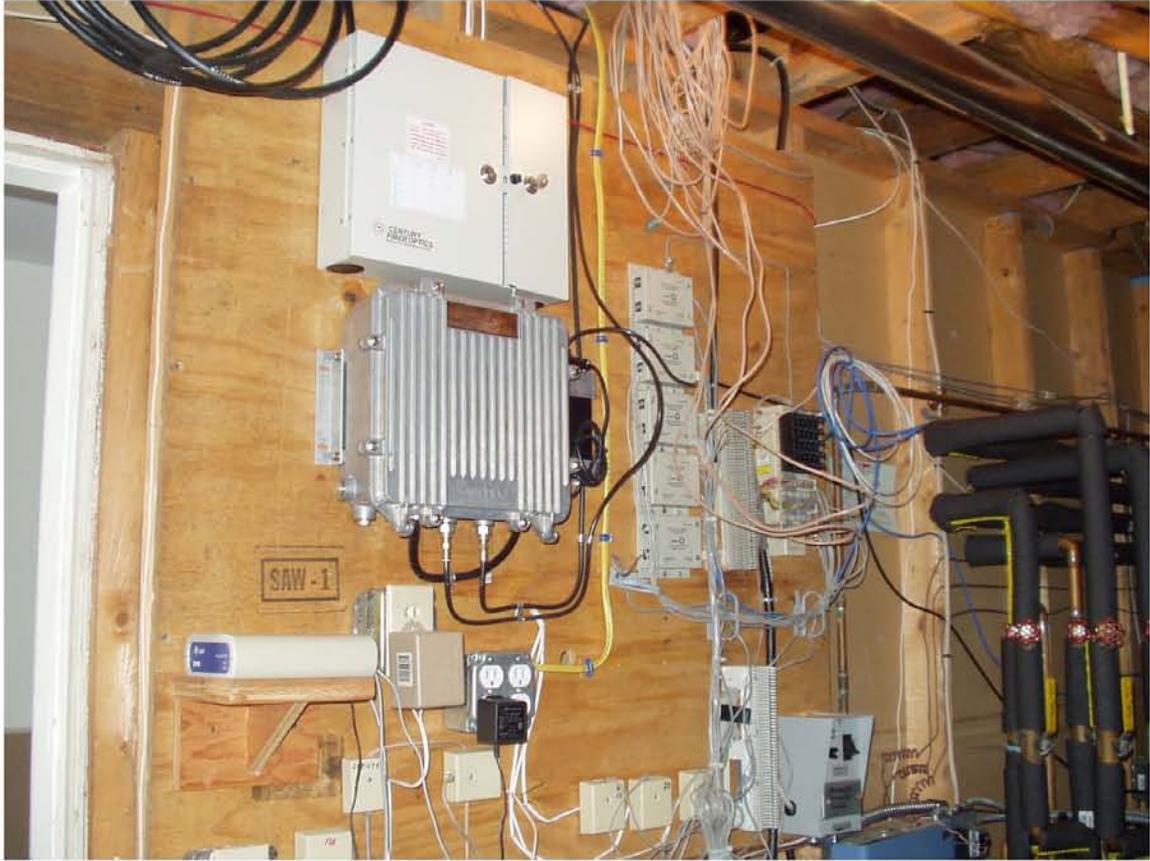
**TOWN HALL DATA/TEL AND CATV HEAD END IN ATTIC**

- Data and telephone wiring in the building is not code compliant with wires and cables being draped over doorways and randomly in and through spaces – see pictures attached.

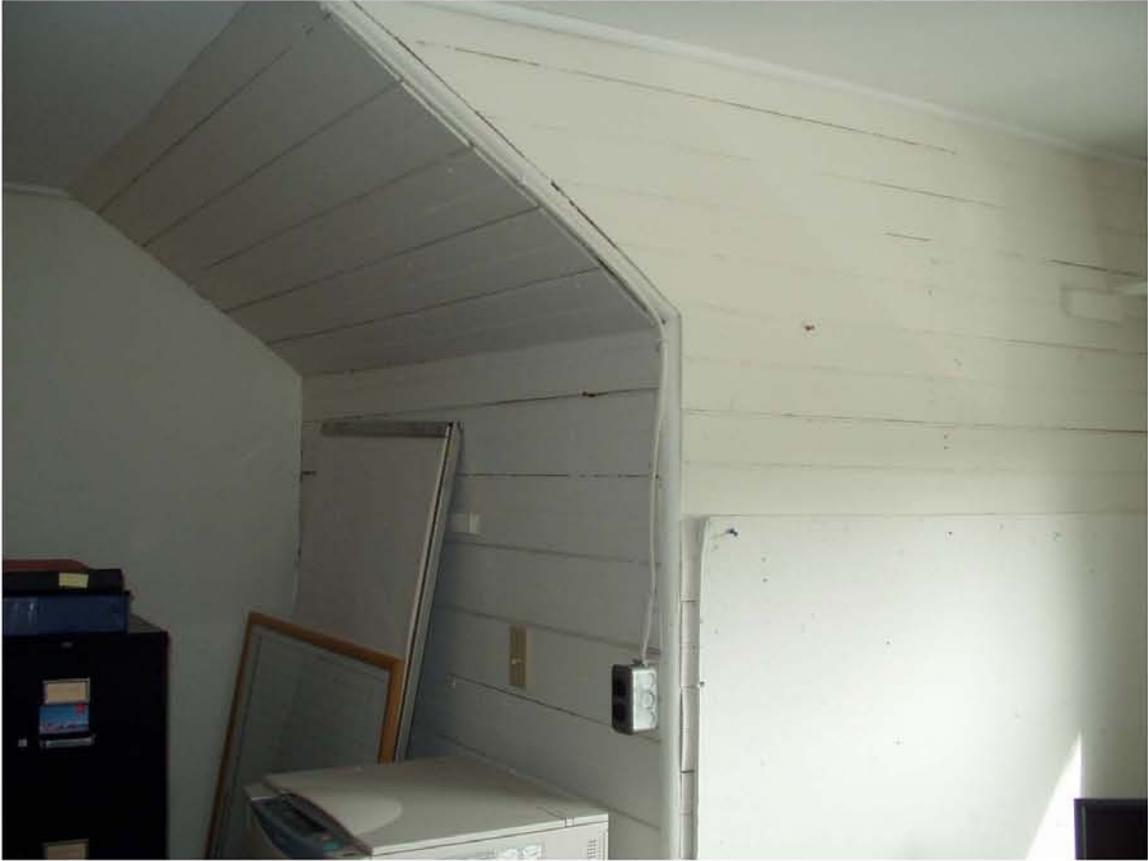
TOWN HALL ILLEGAL WIRING TO RECEPTACLE

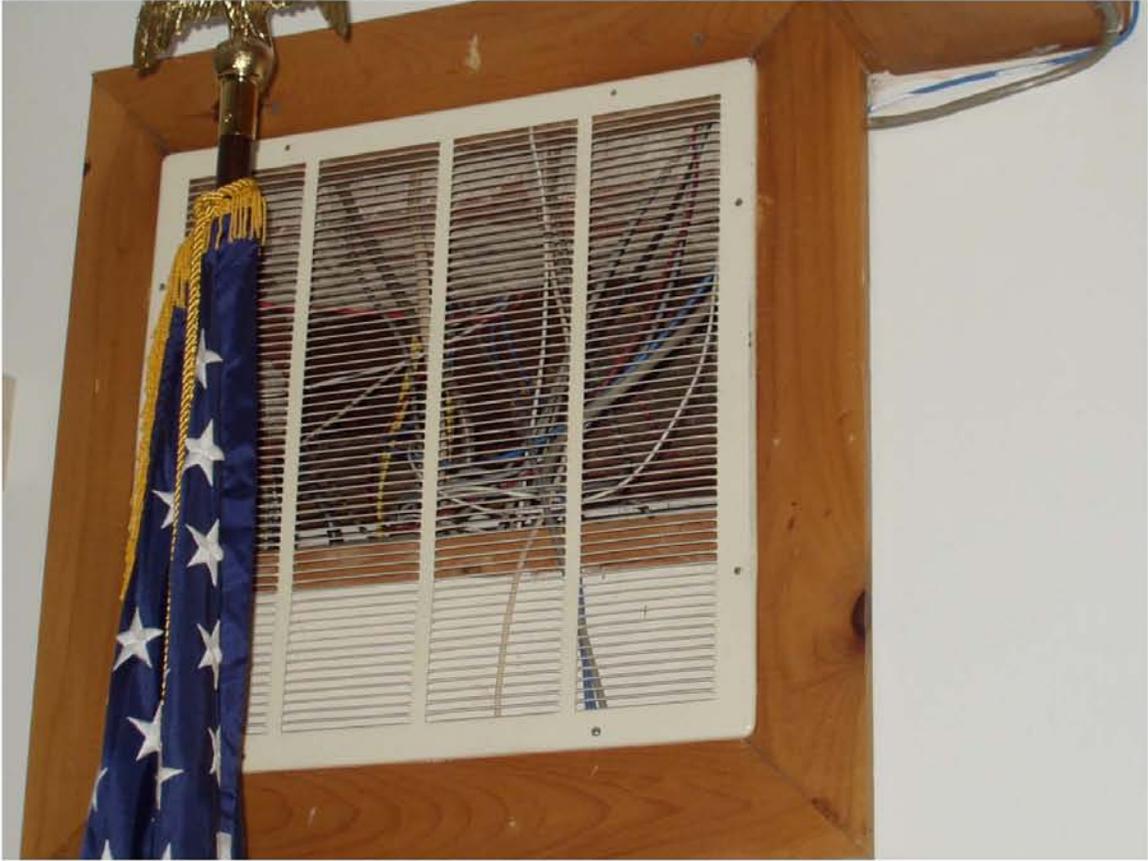
TOWN HALL ILLEGAL WIRING AND CABLING BEHIND AIR GRILLE

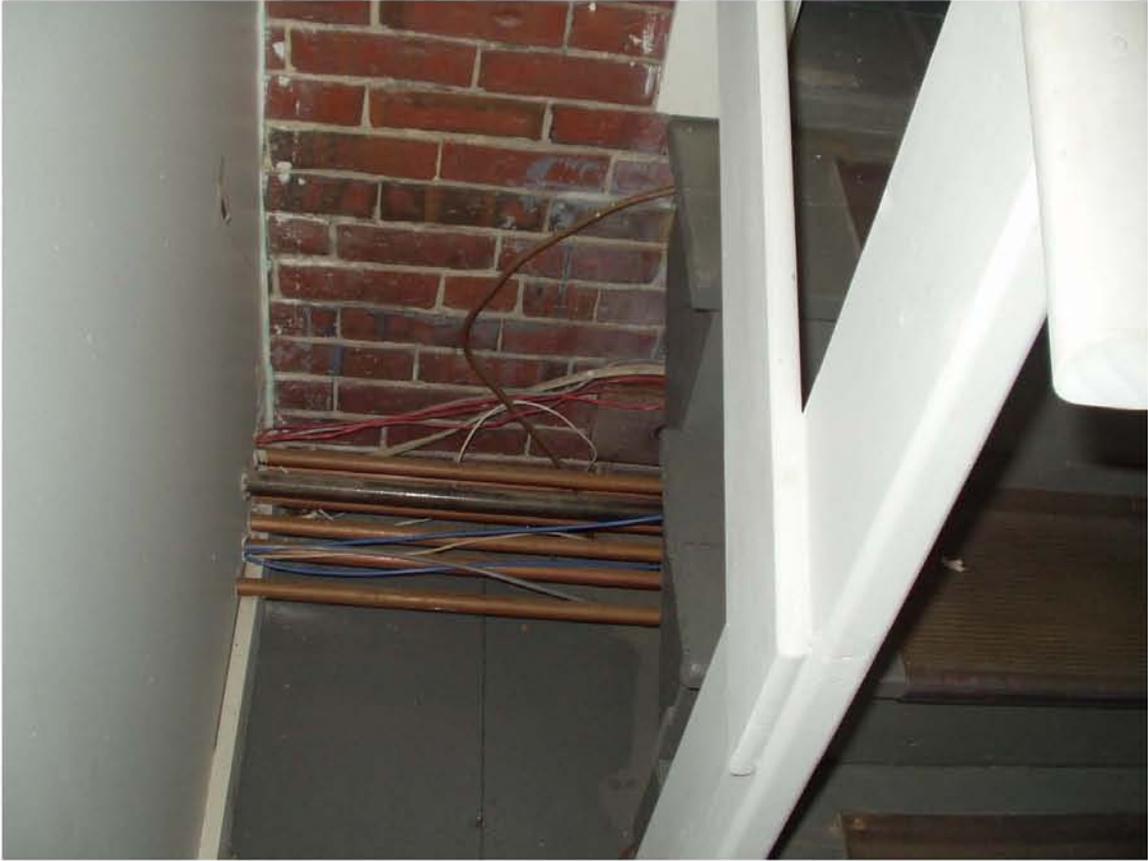
TOWN HALL ILLEGAL WIRING AND CABLING ALONG HEAT PIPES EXPOSED

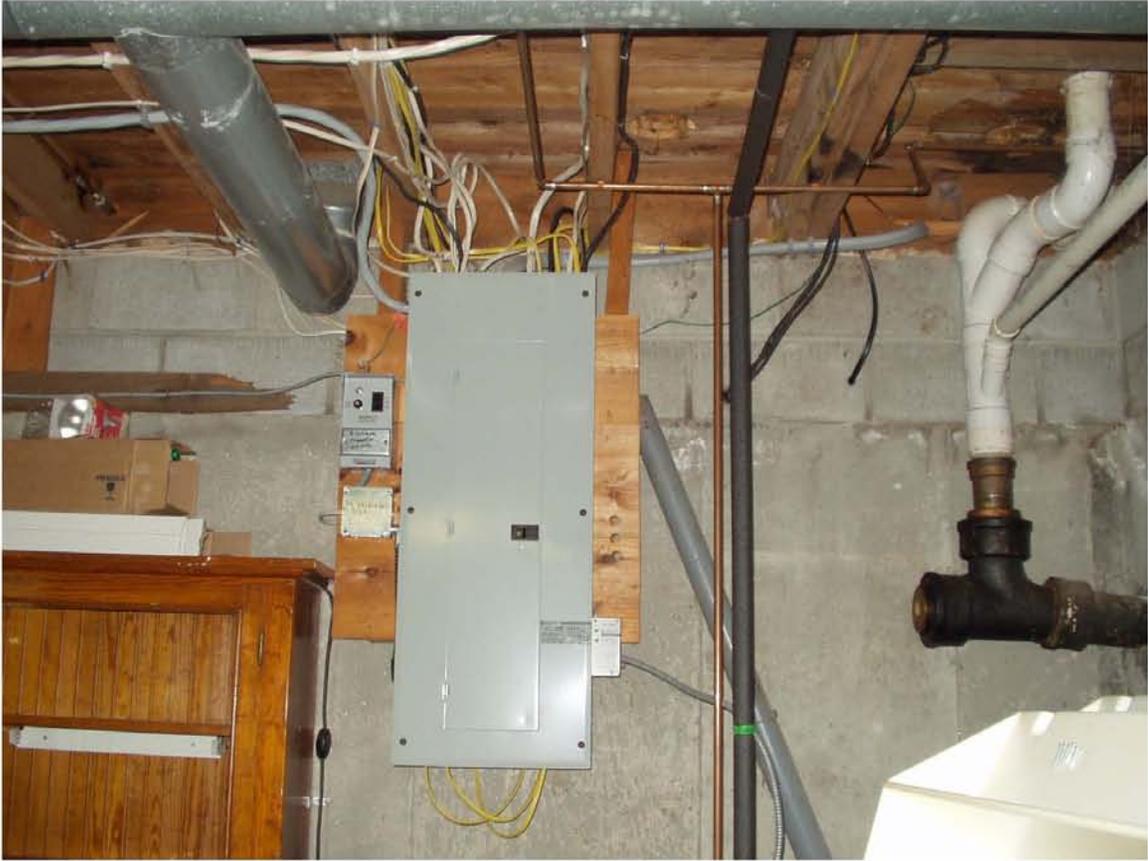
- The main panel has surge protection.
- There is a remote plug connection for connecting a mobile generator during a power outage to maintain heat.
- Most of the wiring is NM cable (“Romex”)

LIBRARY MAIN PANEL WITH TRANSFER SWITCH ON LEFT FOR  
EMERGENCY GENERATOR TO HEATING CIRCUIT

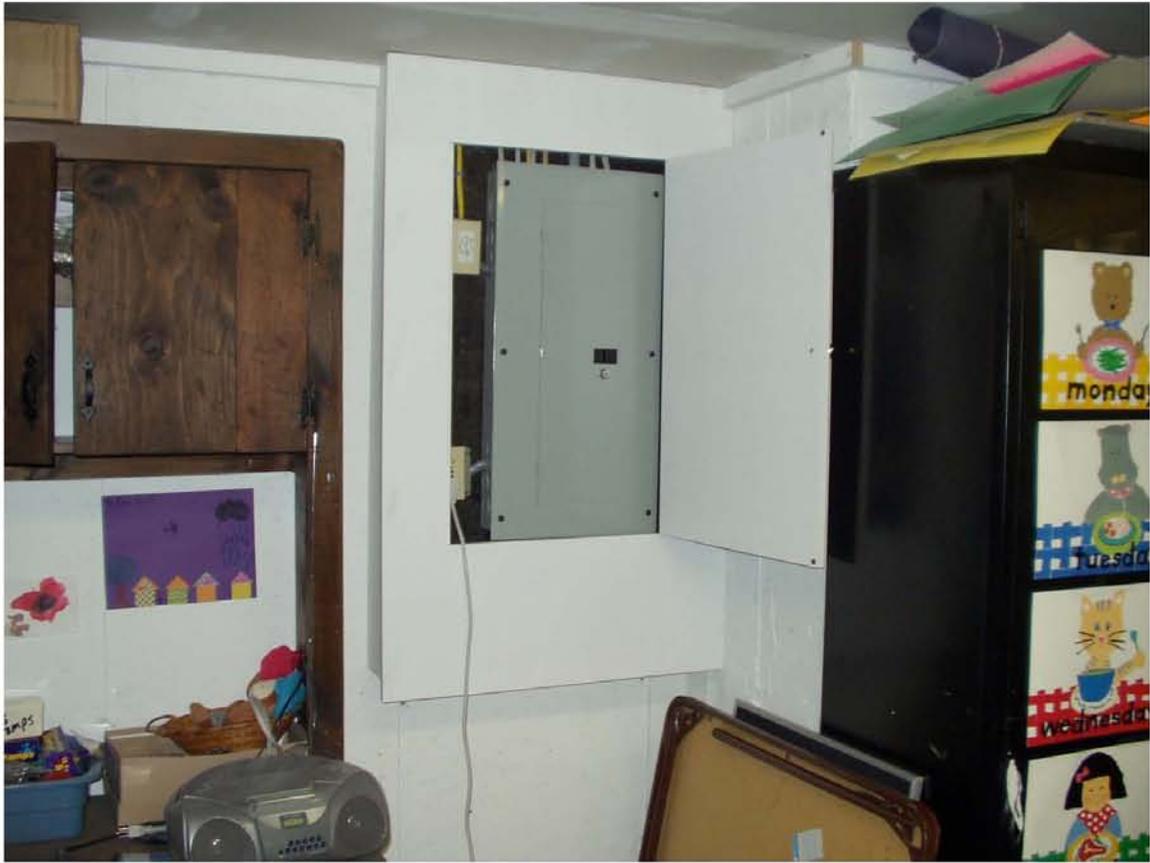
- The sub panel in the basement is located in a boxed in enclosure which does not allow adequate, code required access and clearance.
- The lighting is primarily fluorescent, surface “wrap” fixtures – two lamp, acrylic lensed fixtures with older T12 fluorescent lamps and magnetic ballasts. There are exterior, HID wall packs for exterior lighting.

LIBRARY BASEMENT SUB PANEL

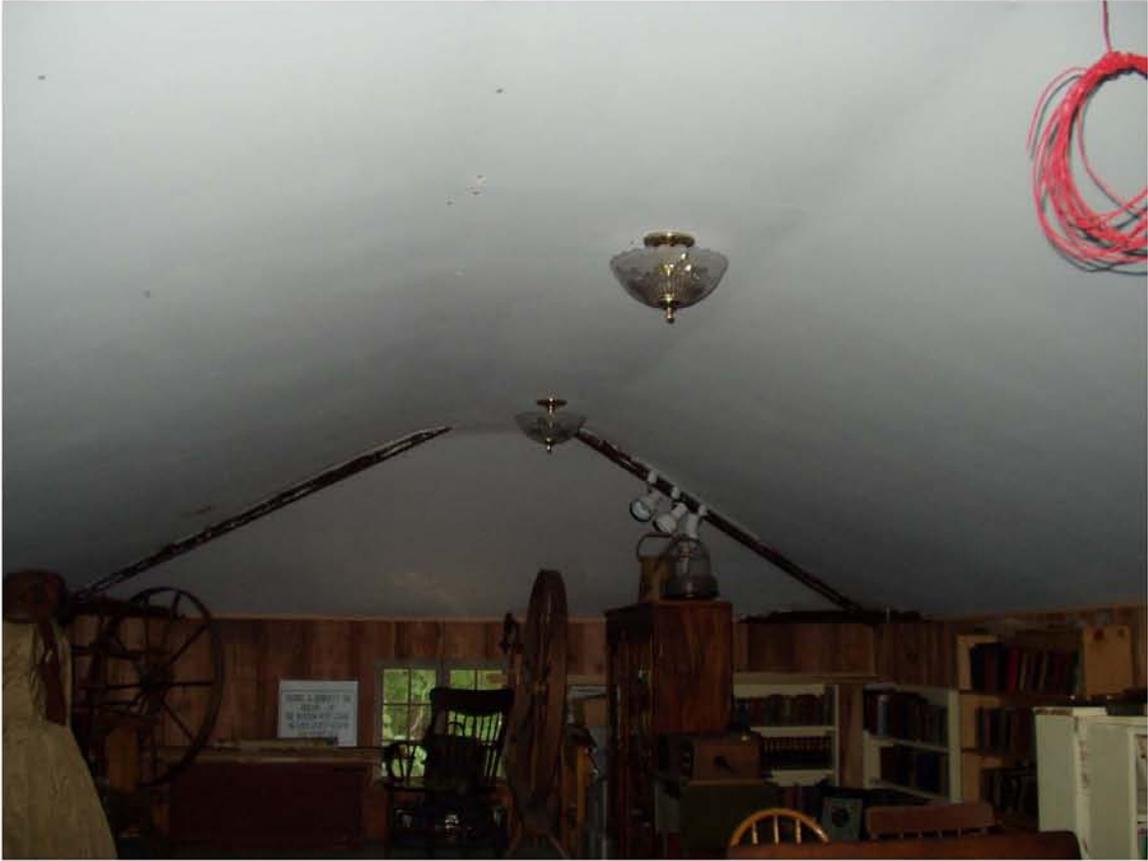
- The electrical service and panel here is a 100 amp, 120/240 volt panel fed from the Library with a 70 amp, 2 pole breaker. There is a main breaker and six single pole breakers for general power and lights. There are 18 or 20 spaces for additional breakers.
- The lighting consists of residential fixtures and some track with incandescent lamps.
- There is really minimal electrical wiring in this building.

HISTORICAL SOCIETY UPSTAIRS LIGHTING
