Energy Audit Report
Lee Recycling Center
Office and Facility
11 Recycling Center Rd, Lee NH
August 16 & 17, 2011

SDES Group
2 Washington Street
Suite 206
Dover, NH 03820
603-617-3767

Recycling Center Office and Facility

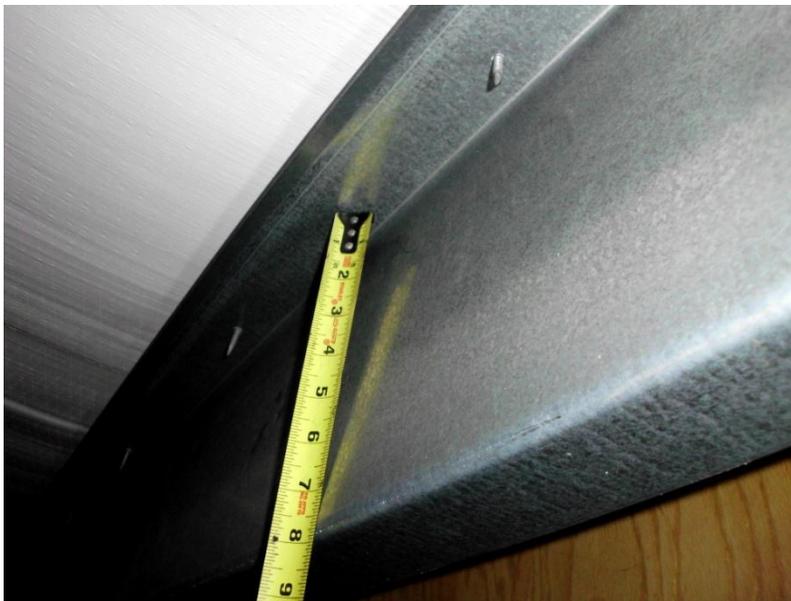
1. Roof System

- The roof structure consists of steel rafters. There is 8” of open rafter depth (beyond the existing insulation).
- There is 2” of fiberglass insulation (R-value 2.8 per inch) below the metal roof surface, held in place with a reinforced plastic air/vapor barrier (similar to Tyvec), creating a “hot” roof system.
 - This system is not an effective thermal barrier, as snow on the roof is melted quickly through heat conduction.

- Add a minimum of 4” closed-cell spray foam insulation (R-value 6.2 per inch) providing a minimum aggregate R-value of 30.

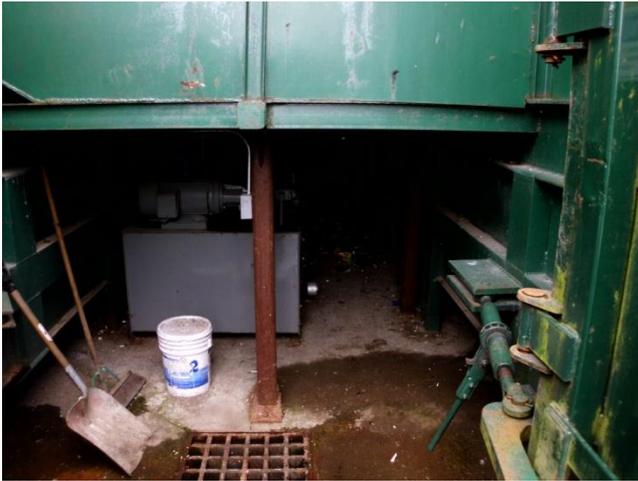
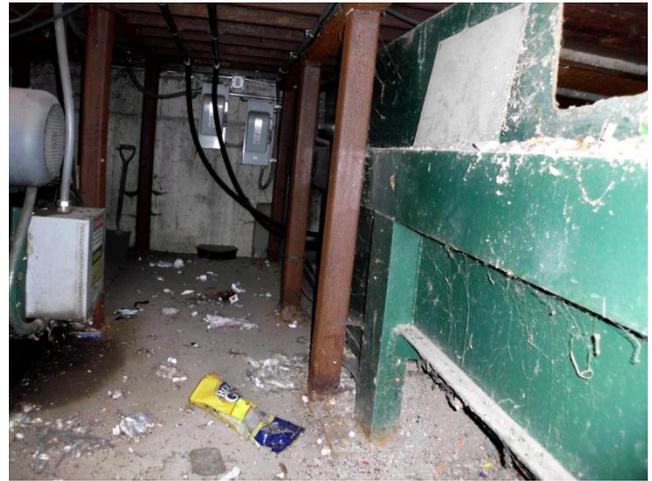
8. Compactor Area Crawl-Space

- The compactor generators are heated during the winter months with electric heaters in an un-insulated crawl space with an open-air access way.
 - Electric costs for heating the compactor generators is \$300 / month.

- Add 3” of closed-cell spray foam at the ceiling (R-6.2 per inch) and cover the steel joists and beams with 1” of closed-cell spray foam.
- Frame the generator crawl space side walls with ½ “ plywood to the exterior, and 2 x 3 framing (flush to the interior surface of the pylons).
 - Insulate the stud bays with 2 1/2” spray foam (R-6.2 per inch and air sealing) to the surface of the framing, then 2” rigid foam insulation over the 2x3 framing (creating a more durable surface, with some reflective heat benefit).
- Frame the front wall with 2 x 4’s at the front pylon (& before the container attachment flange), plywood to the exterior and rigid board insulation.

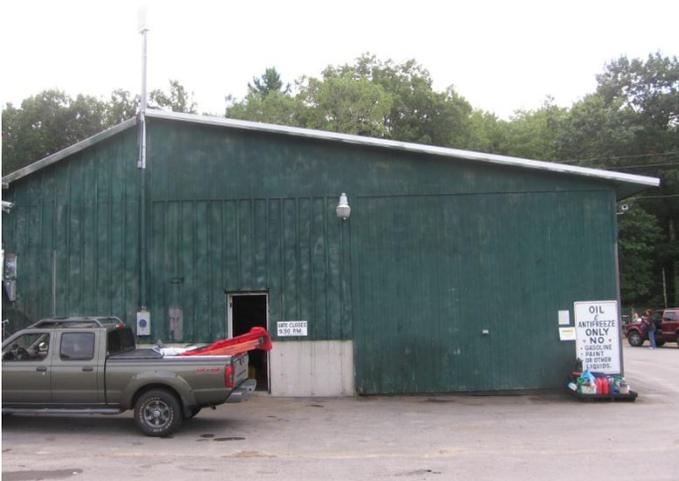
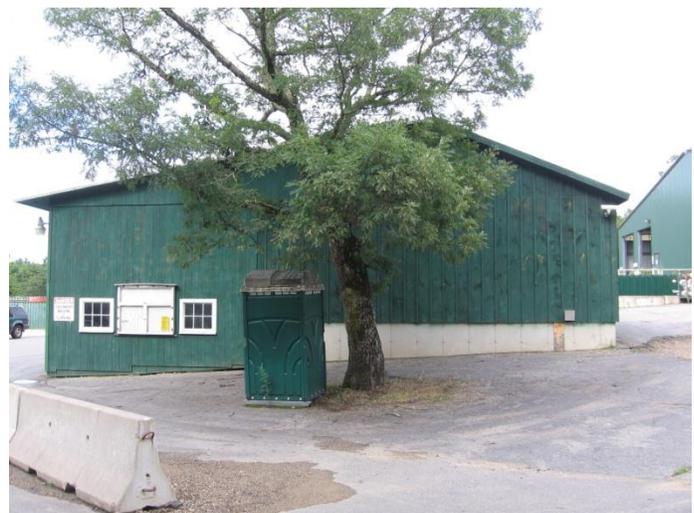
9. Maintenance Building – Detached

- The building is heated with recycled waste oil
- There are plans to build a shed roof building off of the side of the maintenance building for an expanded swap shop (26’ wide x 12’ deep).

- The new swap shop is planned to have R-30 walls and R-50 roof insulation
- There is sufficient waste oil to heat both the maintenance building and the planned new swap shop.
- Another heating system is anticipated to be paid for by the grantor of the waste oil.

- The new swap shop is planned to have R-30 walls and R-50 roof insulation
- There is sufficient waste oil to heat both the maintenance building and the planned new swap shop.
- Additional waste oil heating system is anticipated to be paid in part by NH DES grant program.
